## CIVIL AERONAUTICS BOARD

**ACCIDENT INVESTIGATION REPORT**

TRANS WORLD AIRLINES, INC., LOCKHEED 1049A, N 6902C, AND  
UNITED AIR LINES, INC., DOUGLAS DC-7, N 6324C,  
GRAND CANYON, ARIZONA, JUNE 30, 1956

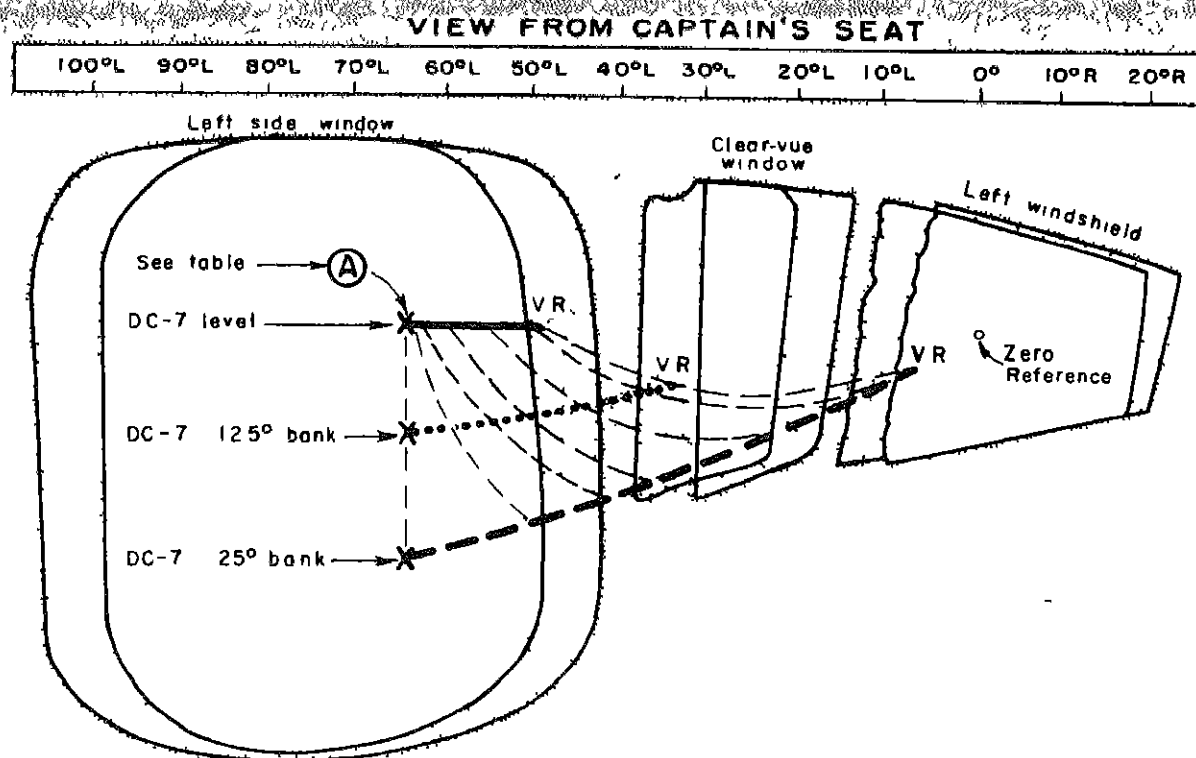
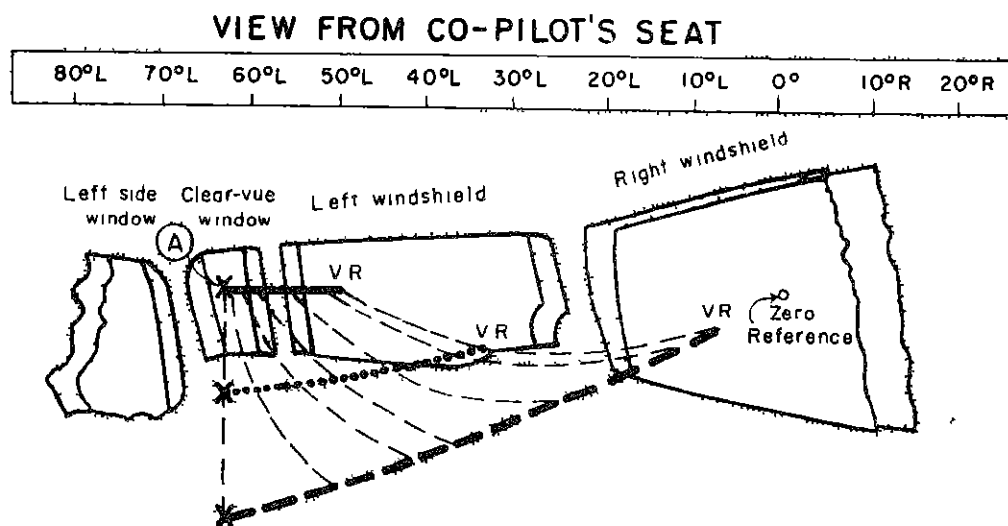
With respect to the DC-7 first officer's position, the L-1049 was within the angular limits of the DC-7 window area during two of the limit considerations and during the early part of the other two. In the "no cloud" factor situations the L-1049 would have been near maximum visual range in two conditions, without relative motion in one, and with relative motion in another. Time opportunity without intervening clouds and with both aircraft straight and level was 120 seconds. For the other three considerations, including the intervening cloud condition, the opportunity varied from 12 seconds to 50 seconds.

Cloud diameter — Miles	(A)	1	2	5	10	-
Approx time to collision — Seconds	12	21	27	38	50	60
Approx distance between aircraft — Miles	8	15	2	33	48	54

TABLE (A) This applies only when both the DC-7 and L-1049 fly straight and level and converge at approx 25° Position on window is constant at point (A) until instant before collision					
Cloud condition and limitation	No clouds and VR 5-6 miles	5 miles diameter	2 miles diameter	1 mile diameter	(A)
Approx time to collision — Seconds	120	109	57	27	17
Approx distance between aircraft — Miles	53	49	25	17	4000'

- DC-7 straight and level and L-1049 in left turn at 25° bank
- ..... DC-7 in right turn at 125° bank and L-1049 in left turn at 125° bank
- DC-7 in right turn at 25° bank and L-1049 straight and level
- X L-1049 position instant before collision
- VR Point at which the L-1049 first appears assuming a visual range of 5 to 6 miles and with crew positions in cockpit assumed as average
- Monocular vision area — where crew members can see with only one eye
- Clear area within windshield or window outline — crew members can see with both eyes
- Opaque area — area around windshield and side windows with no outside vision
- — — — — Dash lines connect corresponding points on three paths shown
- (A) Elongated cloud or cloud shelf diminishing eastward to a point

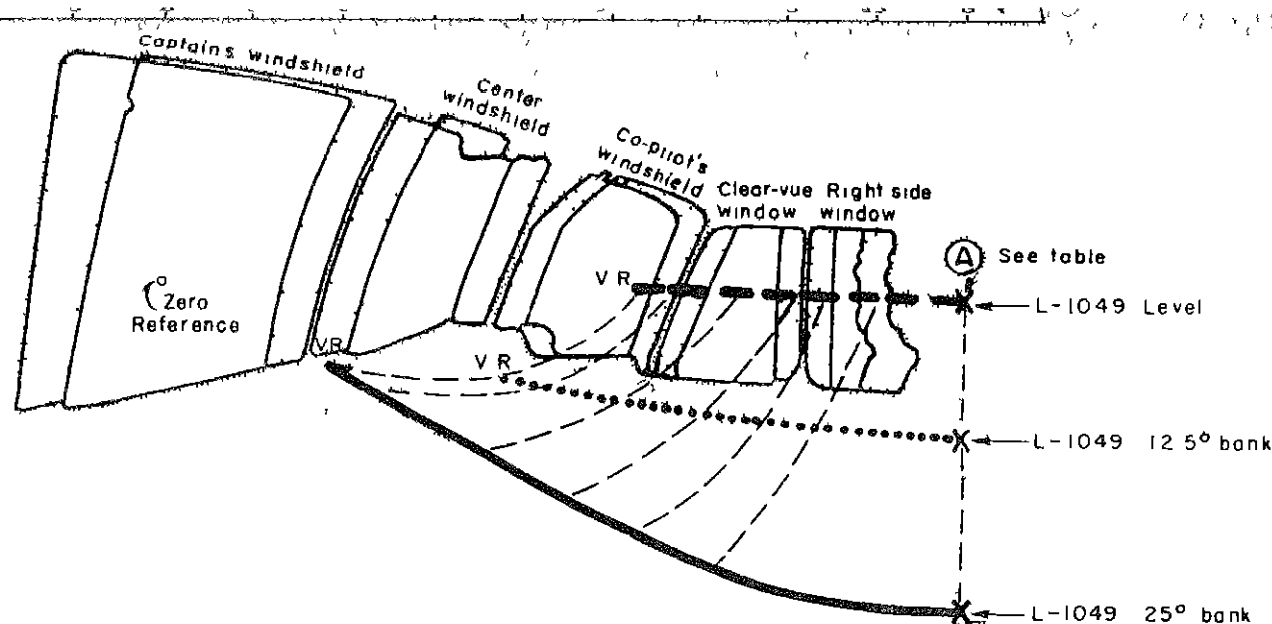
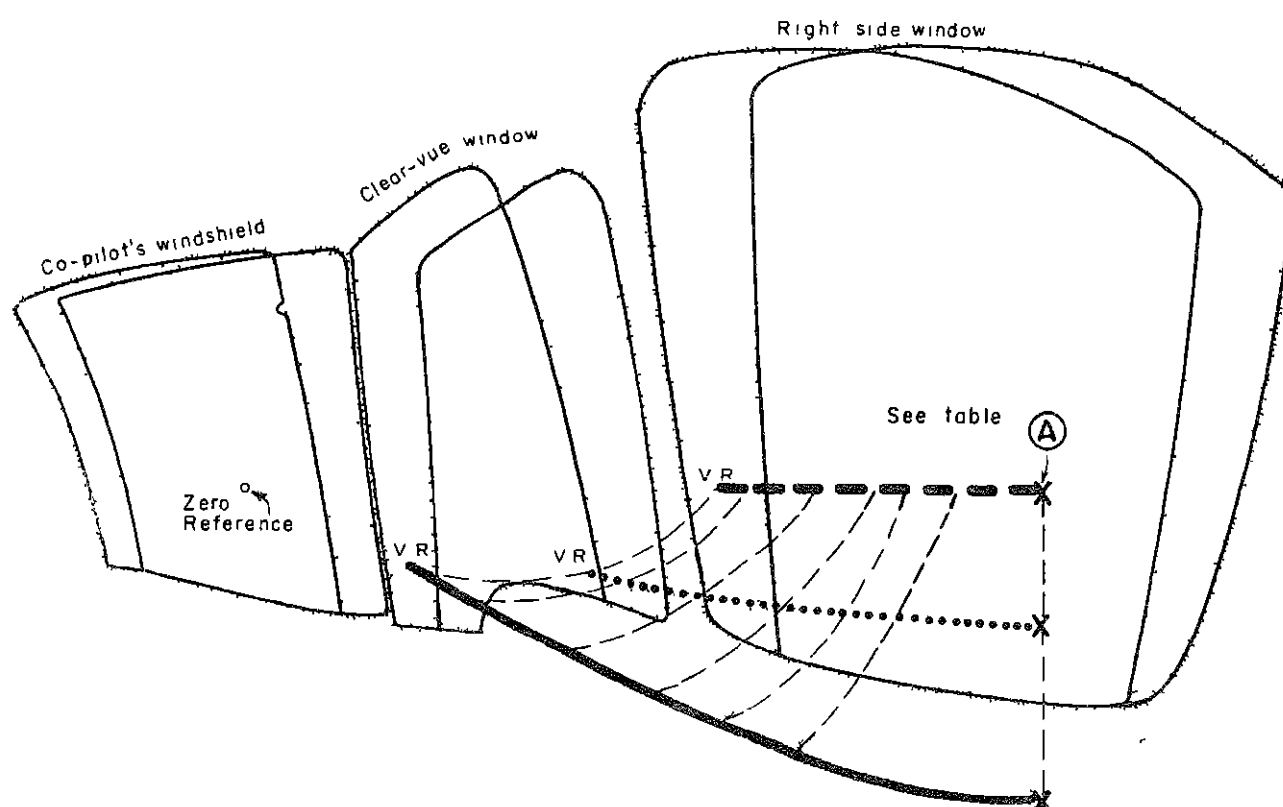
### VIEW FROM CO-PILOT'S SEAT

The study indicates that without the intervening cloud condition the DC-7 was within visual range and within the angular limits of cockpit vision from the L-1049 copilot's seat during three of the four flight path situations. Then the time opportunity varied from 50 to 120 seconds, according to the situation. Two of the displays reveal relative motion. Again, in the worst cloud situation his time opportunity was as low as 12 seconds.

Cloud diameter - Miles	-	10	5	2	1	△
Approx time to collision - Seconds	60	50	38	27	21	12
Approx distance between aircraft - Miles	54	48	33	2	15	8

TABLE (A) This applies only when both the DC-7 and L-1049 fly straight and level and converge at approx 25° Position on window is constant at point (A) until instant before collision					
Cloud condition and limitation	No clouds and V R 5-6 miles	5 miles diameter	2 miles diameter	1 mile diameter	△
Approx time to collision - Seconds	120	109	57	27	17
Approx distance between aircraft - Miles	53	49	25	17	4000'
